PT
TECHNICAL REPORT M-170

Characterization of Fracture of Engineering Materials

FRACTURE CHARACTERISTICS OF STRUCTURAL
STEELS AND WELDMENTS

by
J. Aleszka
Y. G. Kim

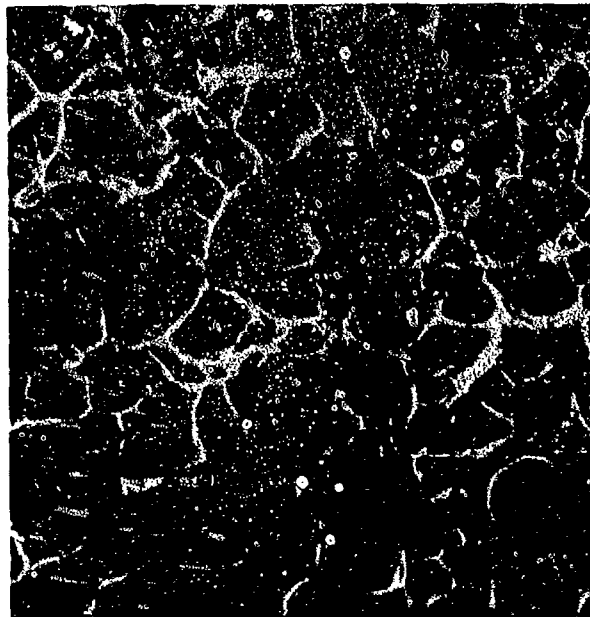
Figure 1. Equiaxed dimples containing inclusions, 4250x.

The shape of these dimples is strongly influenced by the orientation of the major stress axis. Equiaxed dimples (Figure 1) result under local conditions of uni-

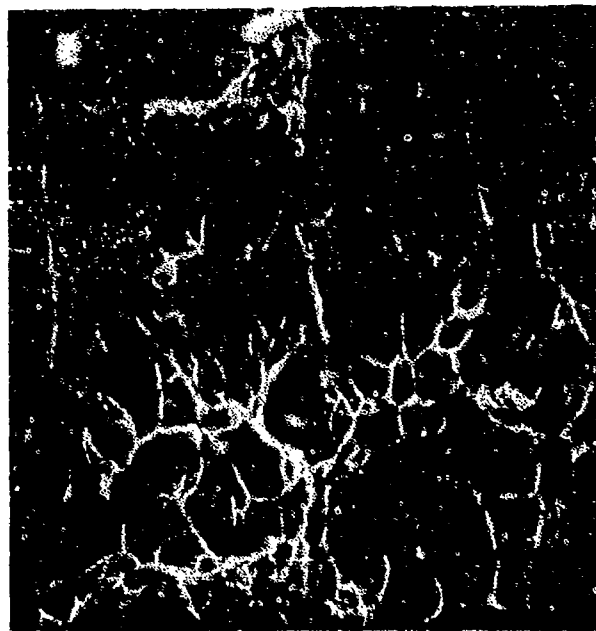
Figure 2. Elongated dimples, 3750x.

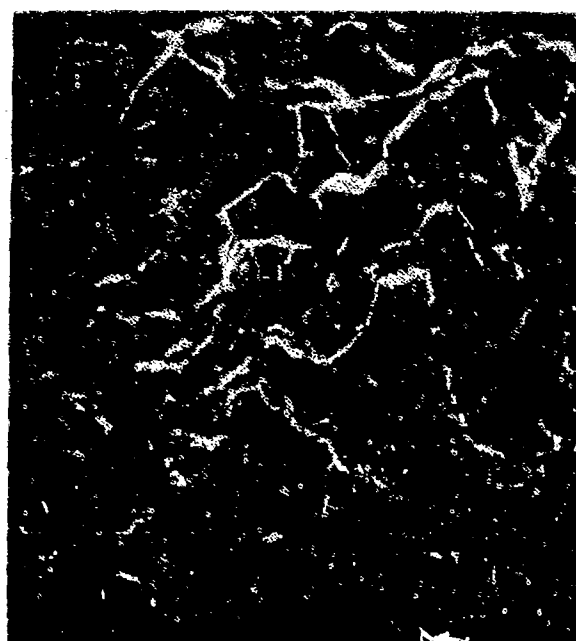
Figure 6. Intergranular fracture, 300x.

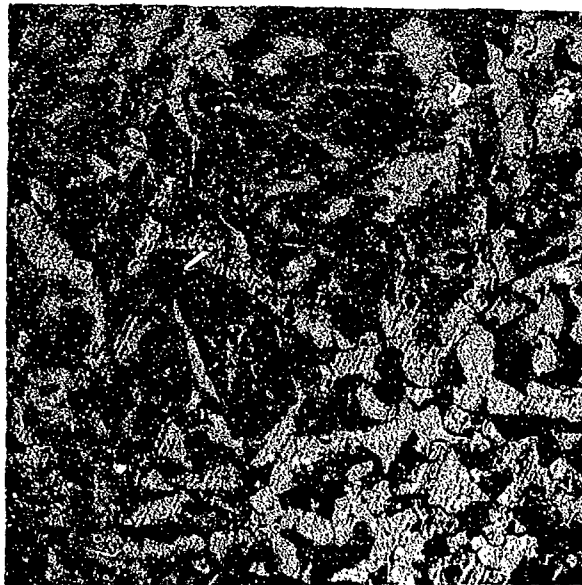
Figure 7. Microstructure of A-36 steel, 200x.

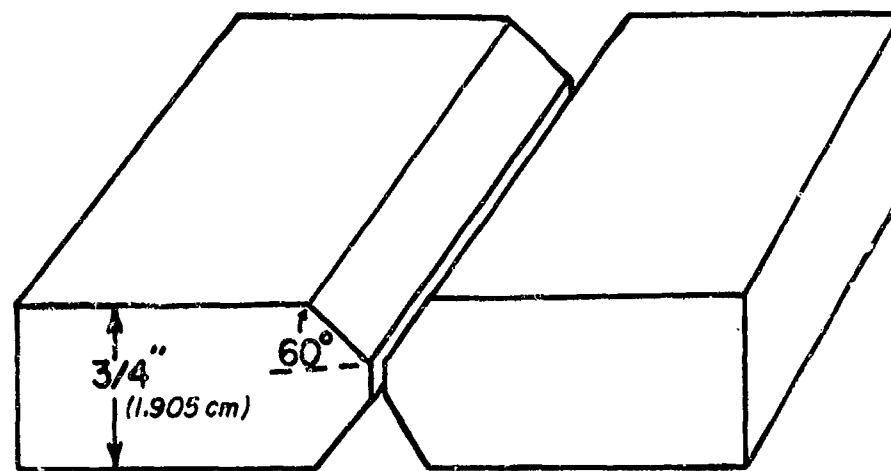
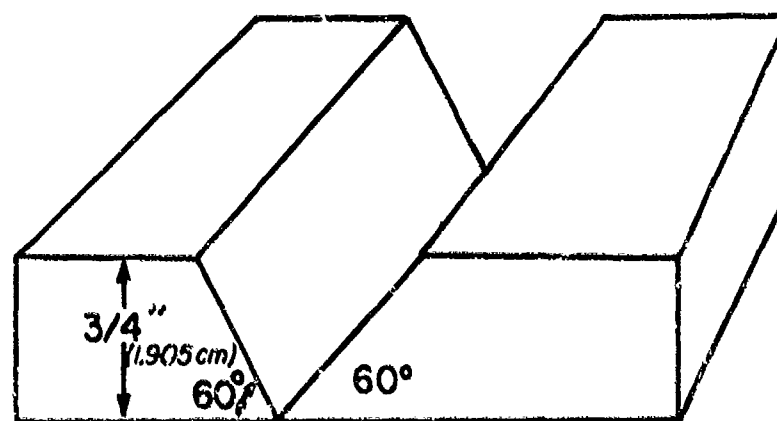
(a) Double Vee Joint

(b) Single Vee Joint

Figure 10. Specimen joints for welding.

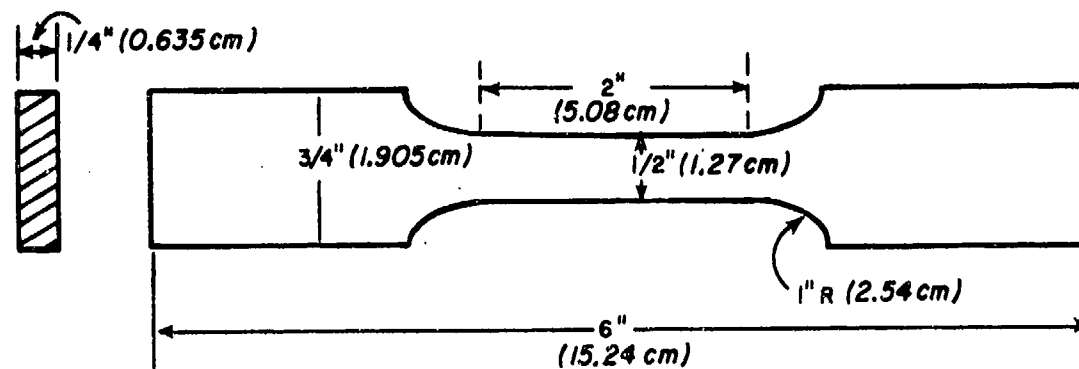
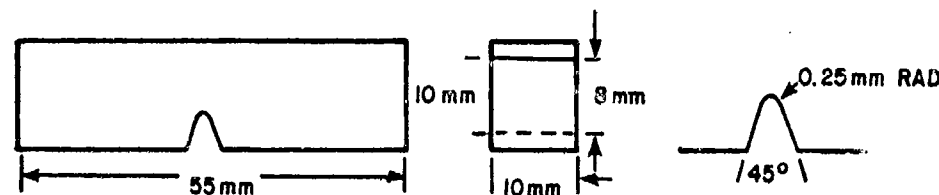
a) Tensile specimen.

b) Charpy specimen.

Figure 11. Specimen geometry for tensile and Charpy impact tests.

Figures 11 and 12 show the specimen geometries for the tensile, impact, and fatigue tests. The tensile and fatigue plate specimens were machined with their longitudinal axes parallel to the rolling direction, while the longitudinal axes of the impact specimens were perpendicular to the rolling direction. The weldment specimens were machined with their longitudinal axes perpendicular to the weld axis.

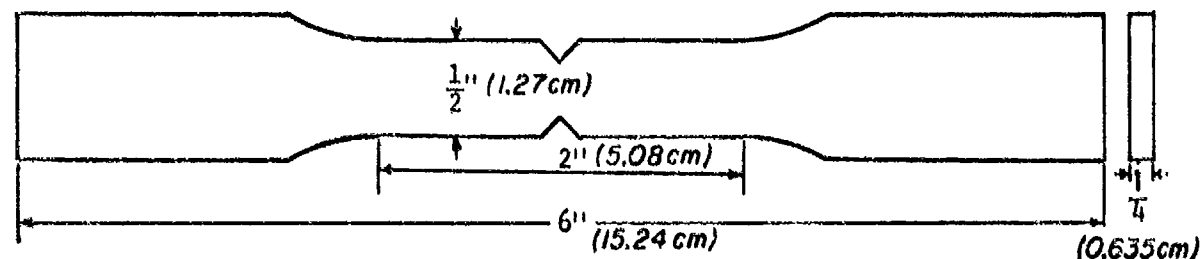
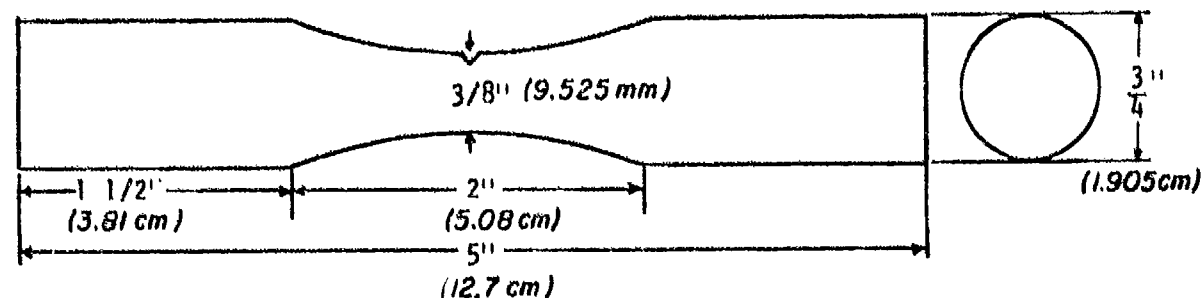
Double notch: 45 deg
 $0.01\text{ in. root radius (}0.254\text{ mm)}$
 $1/8\text{ in. deep (}3.175\text{ mm)}$

Single notch: 60 deg
 $1/16\text{ in. deep (}1.59\text{ mm)}$

Figure 12. Specimen geometry for fatigue tests.

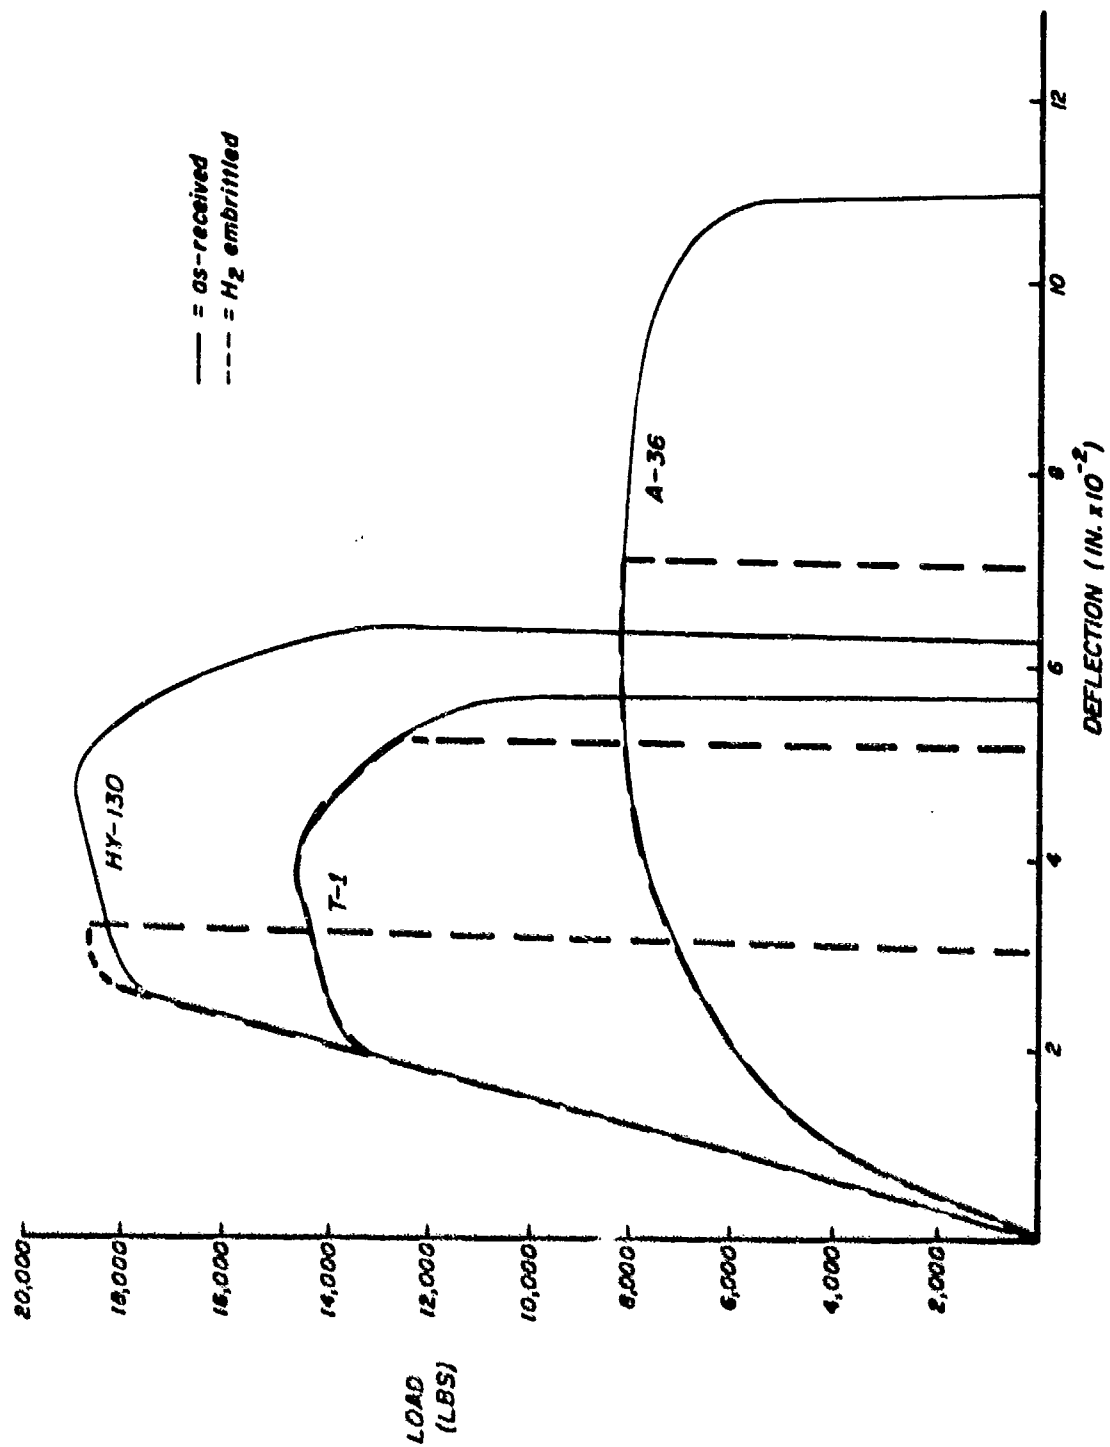
Figure 13. Load-deflection curves for A-36, T-1, and HY-130 steel.

The summary of the tests conducted in this study, typical tensile test load-deflection curves, the variation in absorbed energy with temperature for Charpy tests, and the fatigue lives of unembrittled and embrittled steels are shown in Figures 13 and 14 and Tables 5 and 6.

Hydrogen-charging T-1 steel before fracturing in tension failed to produce any noticeable effect, probably due to lack of diffusion time for the hydrogen. The fracture surface (Figure 45) seems identical to the unembrittled surface (Figure 42). Failure occurred by dimple rupture (Figure 46) and microvoid coalescence in both cases. Secondary microcracks formed as a result of voids joining. While hydrogen embrittling did not affect the ultimate strength of the material, it did result in a minor loss in ductility evidenced by a smaller area under the load/deflection curve (Figure 13).

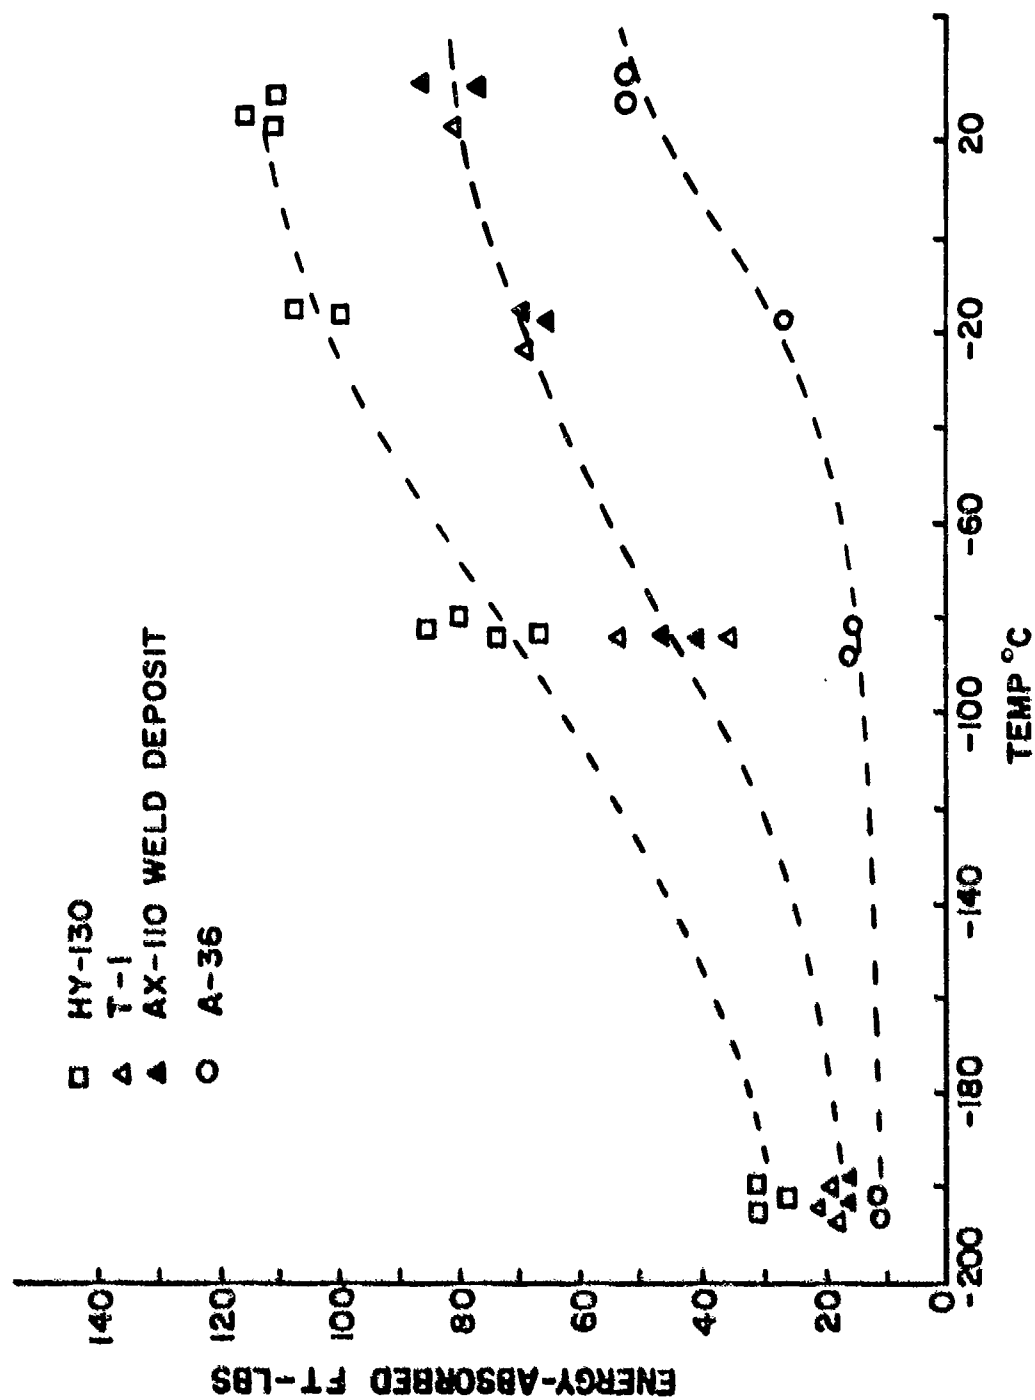
Figure 14. Variation in absorbed energy for A-36, T-1, and HY-130 steel and AX-110 weld deposit.

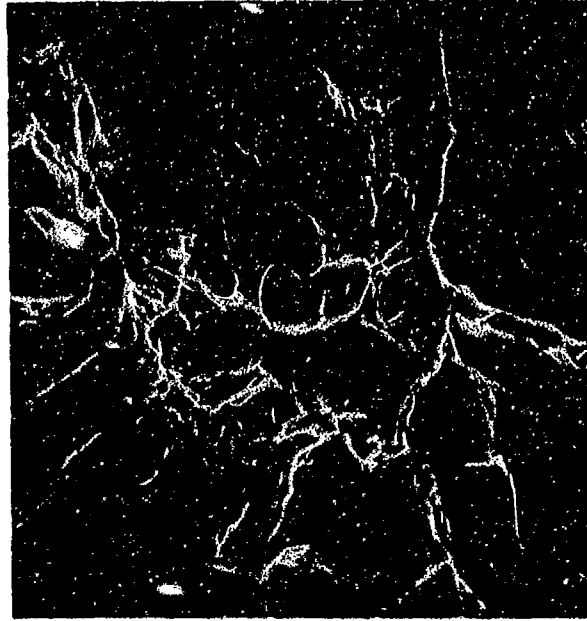
Figure 41. Microvoid coalescence interspersed among cleavage facets in central region of A-36 Charpy specimen tested at room temperature, 1000x.

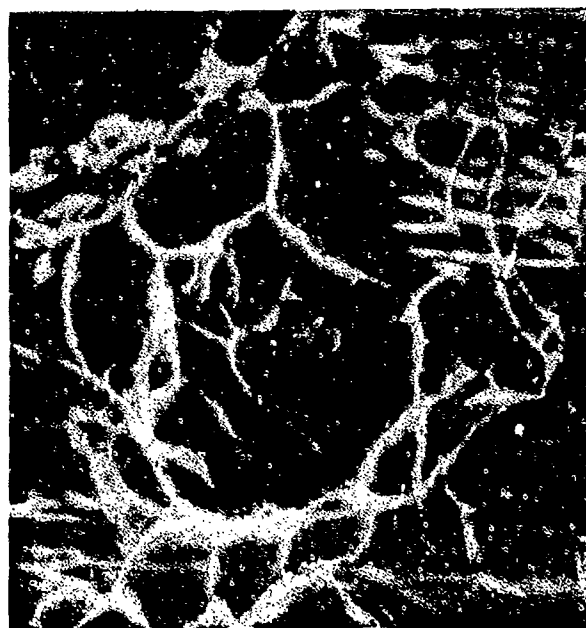
Figure 44. Equiaxed dimples containing inclusions, 7500x.

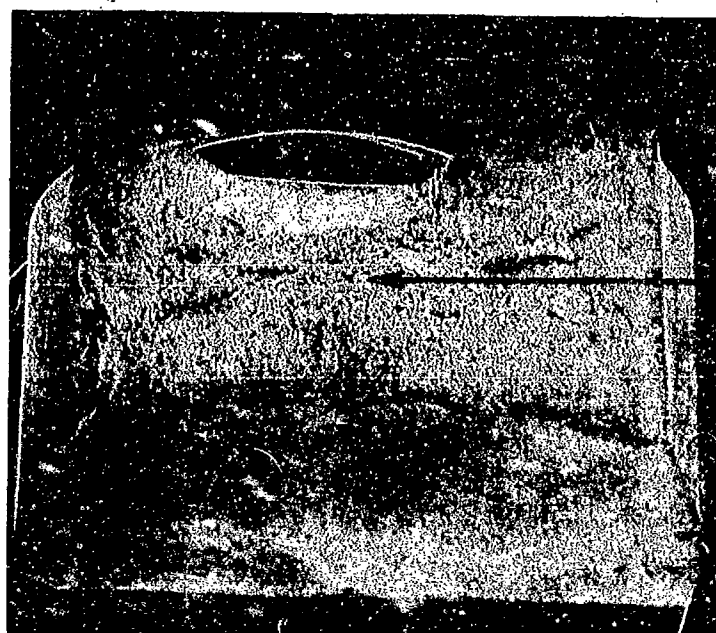
Figure 45. Tensile fracture surface of hydrogen-embrittled T-1 steel, 8x.

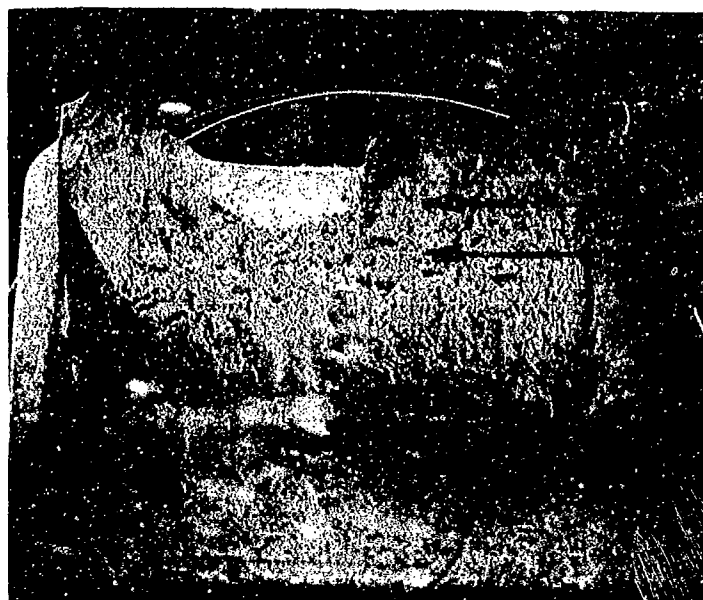
Figure 47. Tensile fracture surface of temper-embrittled steel, 8x.

When T-1 steel was subjected to temper embrittlement, the tensile fracture surface (Figure 47) consisted entirely of dimple rupture and microvoid coalescence (Figures 48 and 49). Although this is identical to the failure mode of the as-received specimen, it does not mean that the steel was not embrittled. Schultz and McMahon²⁴ found that temper embrittling an alloy with composition similar to that of T-1 steel by step-cooling produced the same type of failure mode. They verified the presence of embrittlement by observing the corresponding increase in the transition (from brittle to ductile) temperature. Since the fracture surface alone is not sufficient to identify the presence of embrittlement, further tests such as the Charpy impact test should be performed to verify its presence.

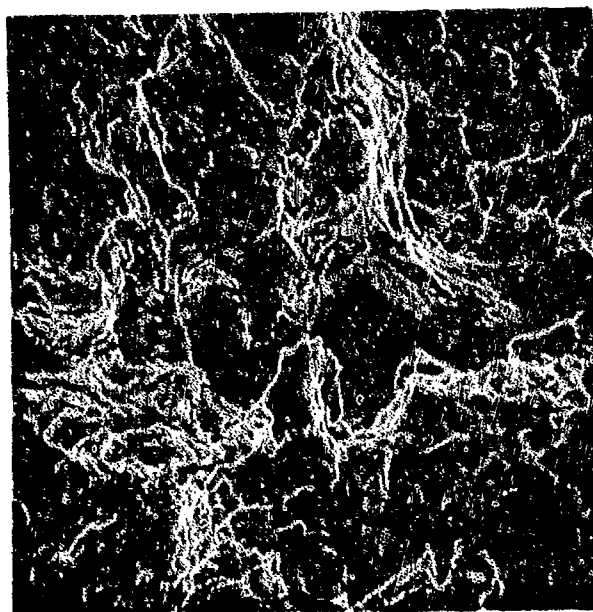
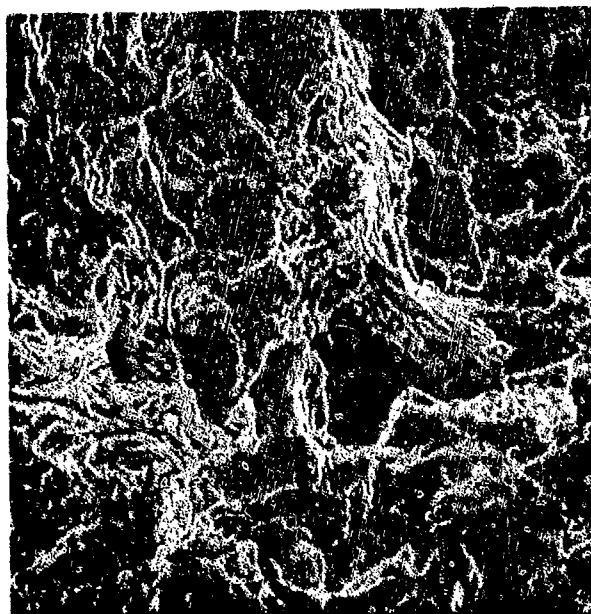
Figure 52. Stereo micrograph of the fatigue zone in T-1 steel, 1600x.

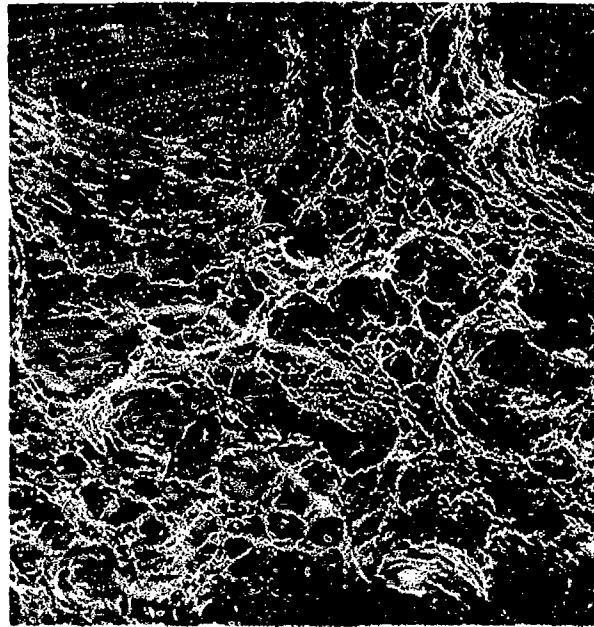
Figure S3. Tensile overload region of T-1 fatigue specimen, 700x.

The fracture surface of an unembrittled double-notched T-1 plate specimen broken in fatigue (Figure 50) consisted of a fatigue zone near each notch and a region of tensile overload in the center of the specimen. The striations in the fatigue zone (Figure 51) were initiated parallel to the machined notch; however, secondary cracking began near the tensile overload region, and the striations became multi-directional (Figure 52). The small holes resulted from large inclusions which were pulled from the matrix as the fatigue crack advanced. A cracked inclusion remains at the bottom of one of the holes. The tensile overload region (Figure 53) consisted of equiaxed dimples of varying sizes.

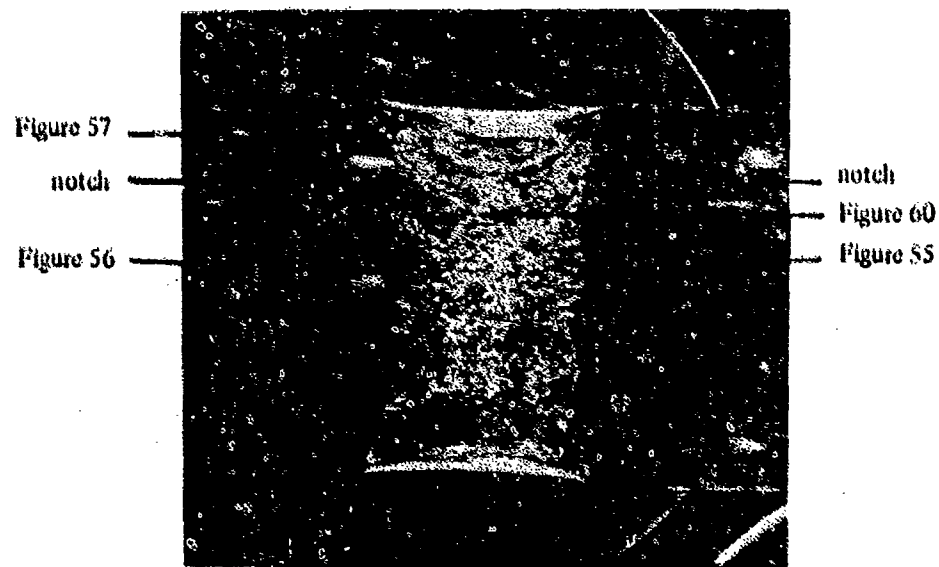
Figure S4. Fracture surface of hydrogen-embrittled T-1 plate fatigue specimen, 8x.

fatigue (Figure 54) was also composed of fatigue regions near the notches and a tensile overload region. The fatigue region, however, was not flat, but consisted of parabolic contours (Figure 55). Photographing these contours at different tilt angles revealed that the parabolic contours were actually craters in the fracture surface (Figures 56 and 57). The shape of the craters can be seen in the optical micrograph (Figure 58) taken from a section in the fatigue zone perpendicular to the machined notch. Many of these craters contained cracks in the bottom perpendicular to the machined notch. Failure occurred by quasi-cleavage inside the craters, while considerable secondary cracking outside resulted in multi-directional fatigue striations. There were no fatigue striations evident near the notch.

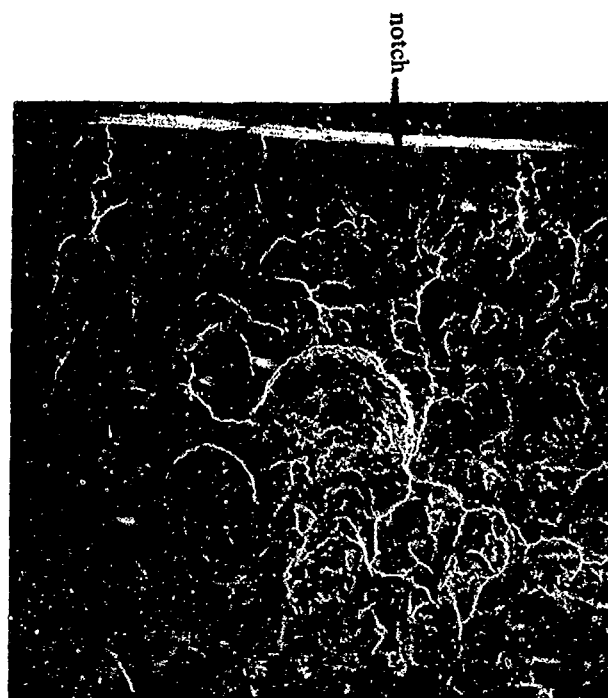
Figure 55. Fatigue zone of hydrogen-embrittled T-1 plate fatigue specimen, 60x.

The hydrogen-embrittled HY-130 fatigue sample is shown in Figure 94. The fatigue region (Figure 95) differs considerably from the unembrittled fatigue region (Figure 90). The parabolic contour lines on the fracture surface are similar to those on the hydrogen-embrittled T-1 fatigue sample (Figure 55). A stereo photograph of one of these contours (Figure 96) shows that like those on the hydrogen-embrittled T-1 sample (Figure 57), they are deep craters on the fracture surface. The mechanism of formation of these craters in the hydrogen-embrittled HY-130 is postulated to be the same as in the embrittled T-1 steel.

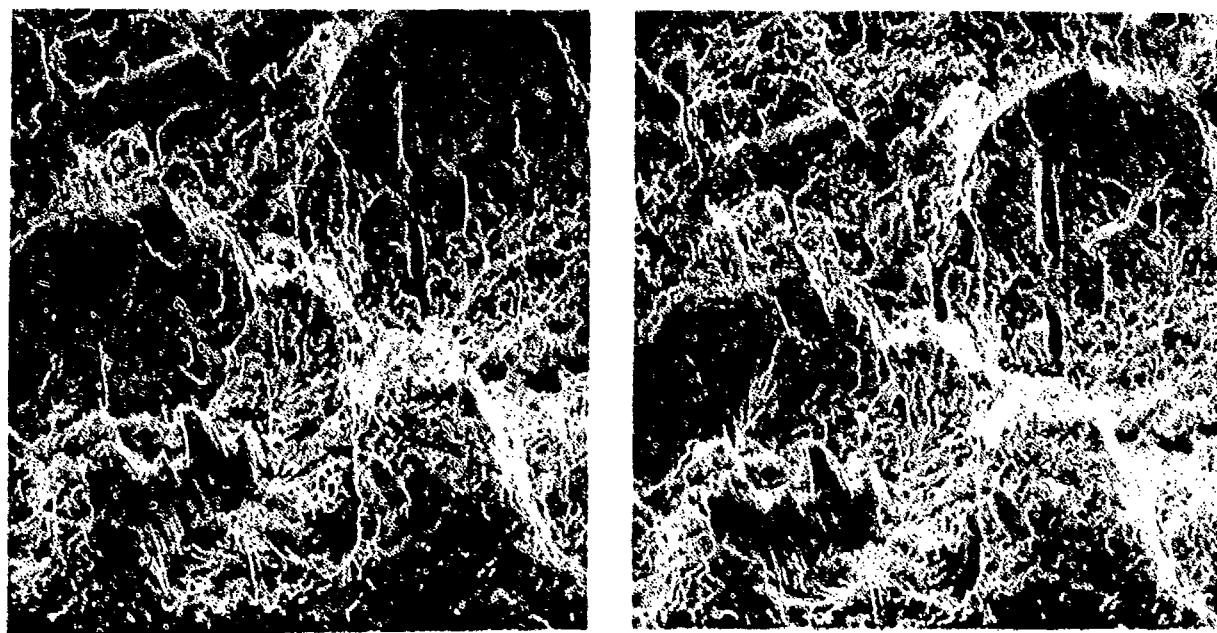
Figure 56. Stereo micrograph of fatigue zone in hydrogen-embrittled T-1 steel, 400x.

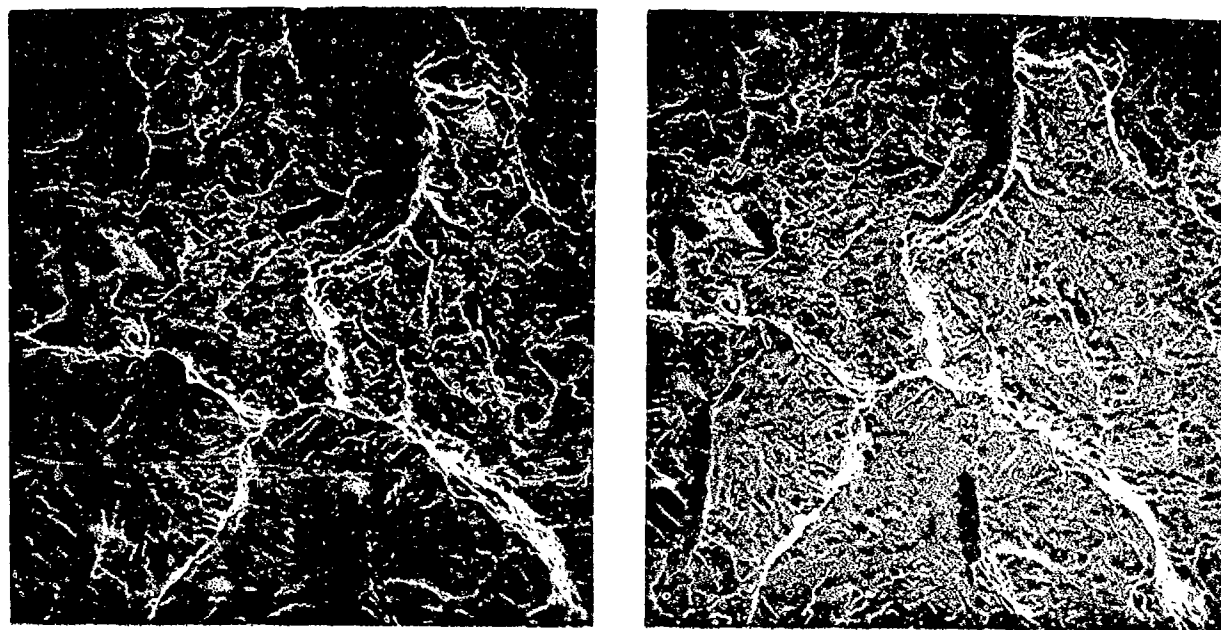
Figure 57. Stereo micrograph of fatigue zone in hydrogen-embrittled T-1 steel, 500x.

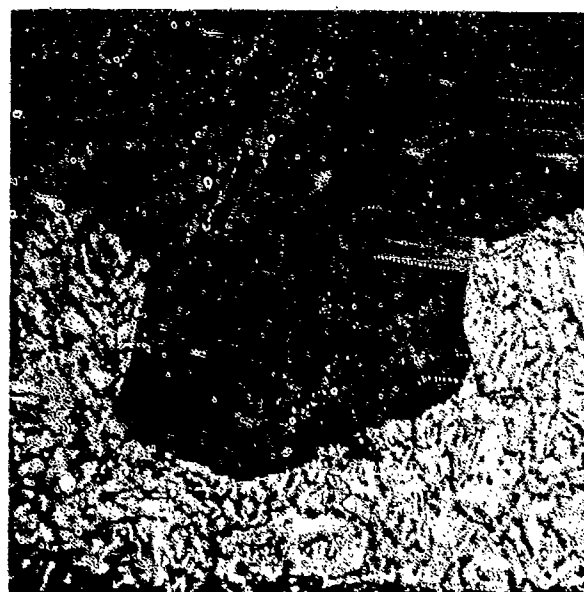
Figure 58. Optical micrograph of a longitudinal section of the fatigue zone in hydrogen-embrittled T-1 steel, 550x.

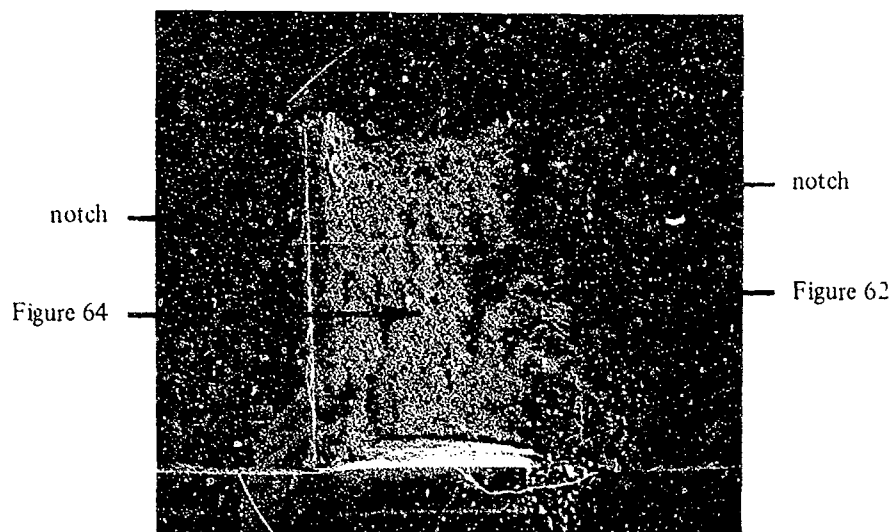
Figure 61. Fracture surface of temper-embrittled T-1 plate fatigue specimen, 10x.

The temper-embrittled T-1 fatigue fracture surface (Figure 61) contained a large amount of lamellar tearing in the fatigue zone (Figure 62). Although a small amount of tearing was noticed in the as-received fatigue sample, temper embrittlement seemed to render the material more susceptible to lamellar tearing. It is believed that the heat treatment cycle reduces the material's short transverse tensile properties so that as the fatigue crack propagates, the large triaxial stresses which build up ahead of the crack front fracture the weakened interface between the matrix and the long stringers of inclusions. As in the unembrittled sample, fatigue striations were parallel to the machined notch (Figure 63). Figure 62 clearly shows the transition from a fatigue to a tensile overload failure mode. As in the previous cases, the central region consisted of dimple rupture (Figure 64).

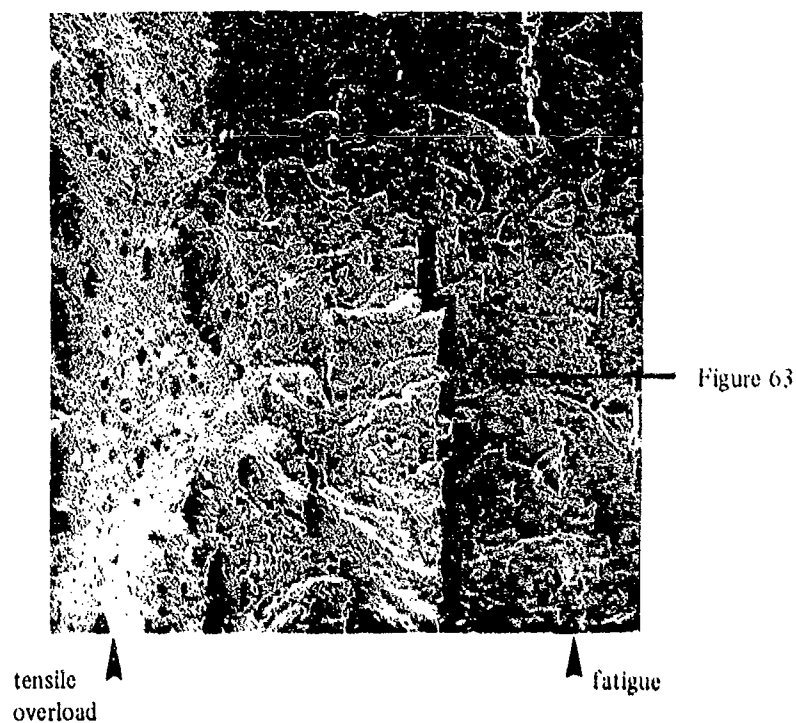
Figure 62. Transition region from fatigue to tensile overload in temper-embrittled T-1 fatigue specimen, 35x.

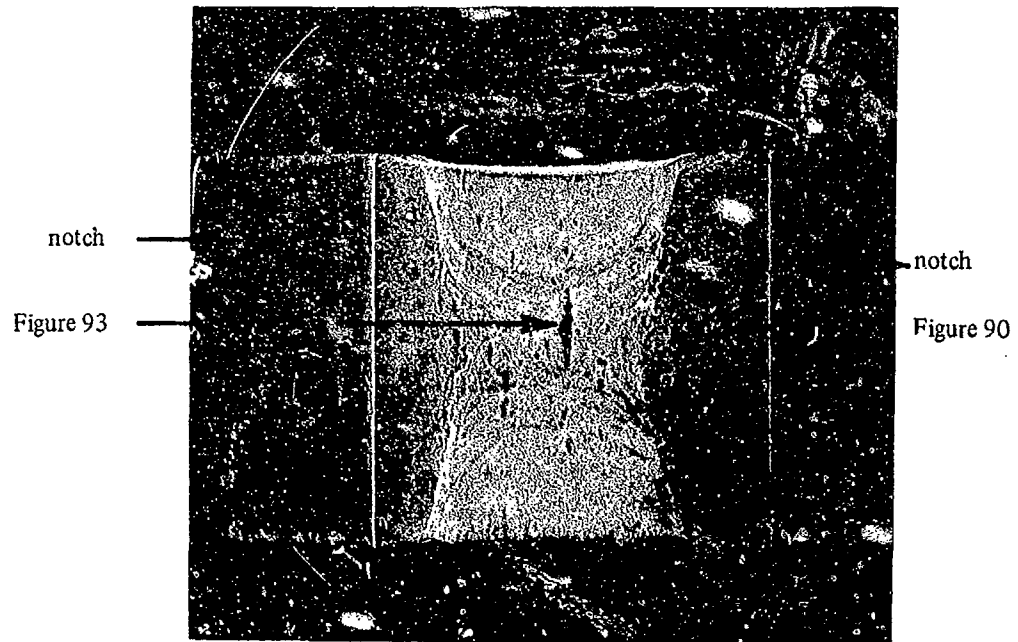
Figure 89. Fracture surface of flat HY-130 fatigue specimen, 8x.

Figures 88 and 89 show the fracture surfaces of round and flat as-received HY-130 specimens fractured in fatigue. The fatigue and overload regions are easily distinguishable in both samples. The fatigue region (Figure 90) consisted of parallel striations indicative of crack front progression across the surface (Figure 91). A stereo micrograph of the fatigue region (Figure 92) shows that the fracture surface is generally flatter than

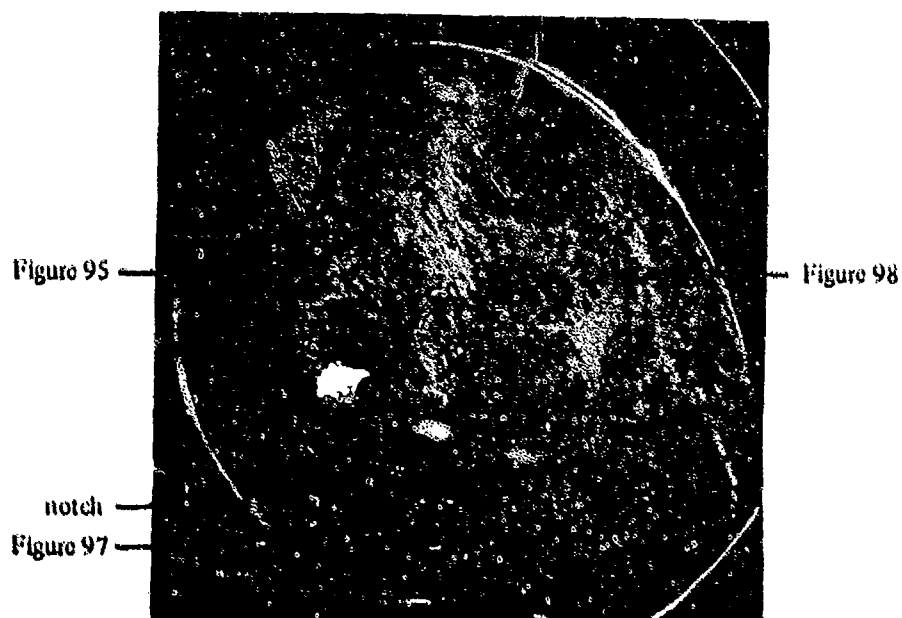
Figure 94. Fracture surface of hydrogen-embrittled HY-130 fatigue specimen, 10x.

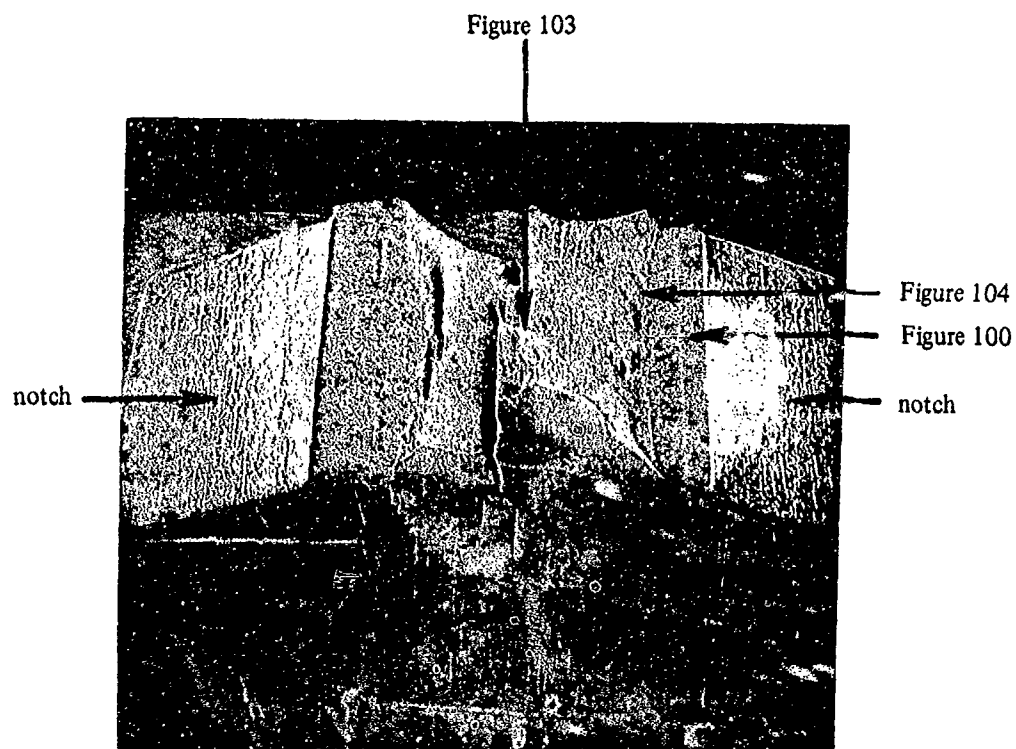
Figure 99. Fracture surface of temper-embrittled HY-130 fatigue specimen, 8x.

Temper-embrittling HY-130 steel prior to testing in fatigue resulted in the fracture surface shown in Figure 99. The fatigue and tensile overload regions are clearly distinguishable. Since considerably more lamellar tearing occurred than in the as-received specimen broken in fatigue, the embrittlement cycle seemed to increase HY-130's susceptibility to such tearing. At a higher magnification, the fatigue region (Figure 100) was found to contain fatigue striations parallel to the machined notch (Figure 101). A stereo micrograph of the fatigue region (Figure 102) shows that crack propagation occurred on relatively few levels, as in the as-received specimen. In the tensile overload region, failure along the lamellae occurred by slipping, tearing, and microvoid coalescence (Figure 103). A region of intergranular fracture was observed between the fatigue zone and the tensile overload region (Figure 104). Most of the failure in this region was intergranular (Figure 105), presumably along prior austenitic grain boundaries; there were also regions of microvoid coalescence (Figure 106).

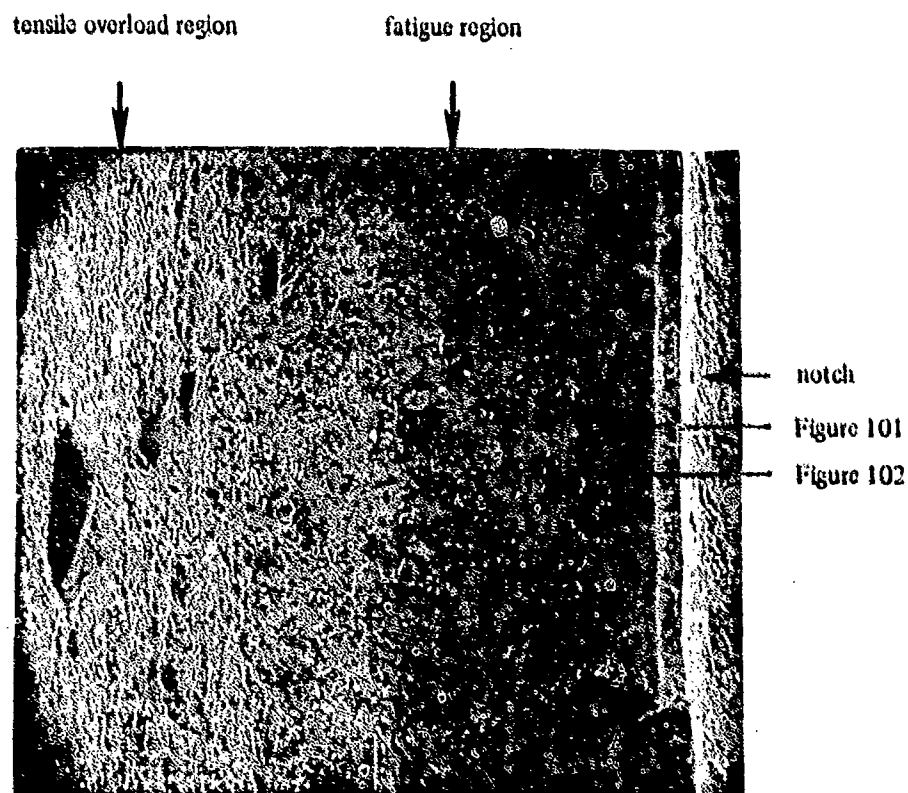
Figure 100. Fatigue region of temper-embrittled HY-130 fatigue specimen, 60x.

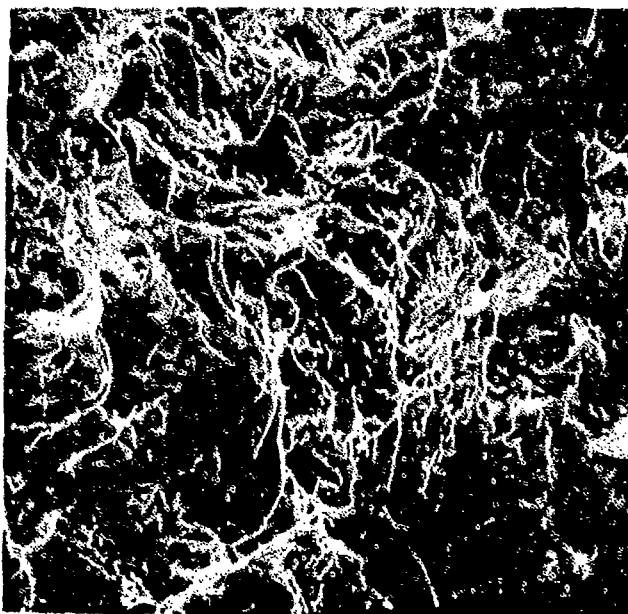
Figure 108. Cleavage fracture in HY-130 Charpy specimen tested at -196°C , 1600x.

The fracture surface of an HY-130 Charpy sample broken at -196°C (Figure 107) consisted solely of cleavage (Figure 108). When failure occurred at -83°C , near the transition temperature, mixed mode fracture occurred (Figure 109). The outer regions consisted of dimple

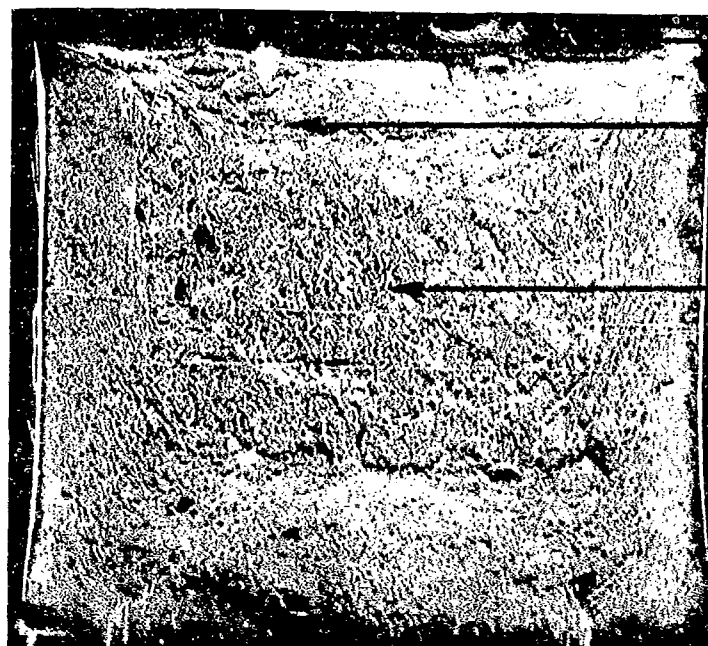
Figure 109. Fracture surface of HY-130 Charpy specimen tested at -83°C , 10x.

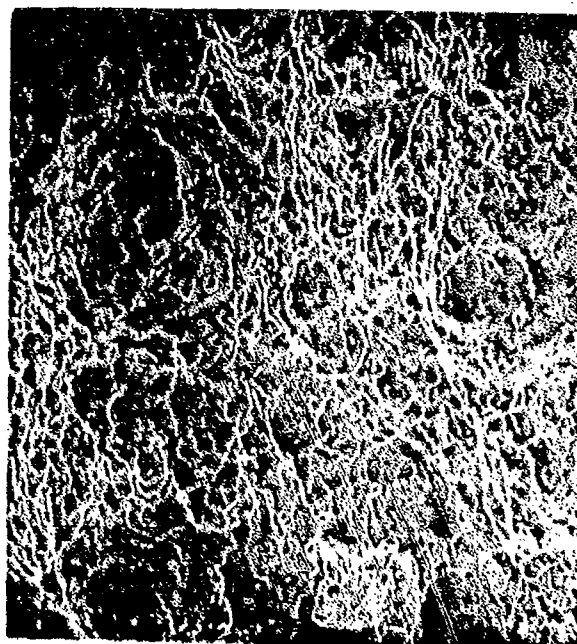
Figure 110. Edge of HY-130 Charpy specimen tested at -83°C , 650x.

rupture (Figure 110), while the mechanism of failure in the central region was cleavage (Figure 111). Failure at -18°C , above the transition temperature, resulted in a fracture surface (Figure 112) consisting entirely of dimple rupture (Figure 113). Fracturing at room temperature produced a fracture surface (Figure 114) similar to the -18°C fracture surface (Figure 113). The mechanism of failure was again entirely dimple rupture (Figure 115).

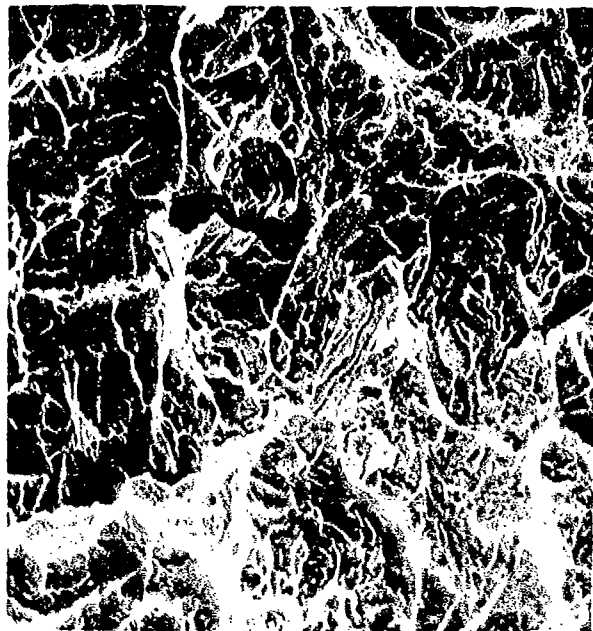
Figure 111. Center of HY-130 Charpy specimen tested at -83°C , 1600x.

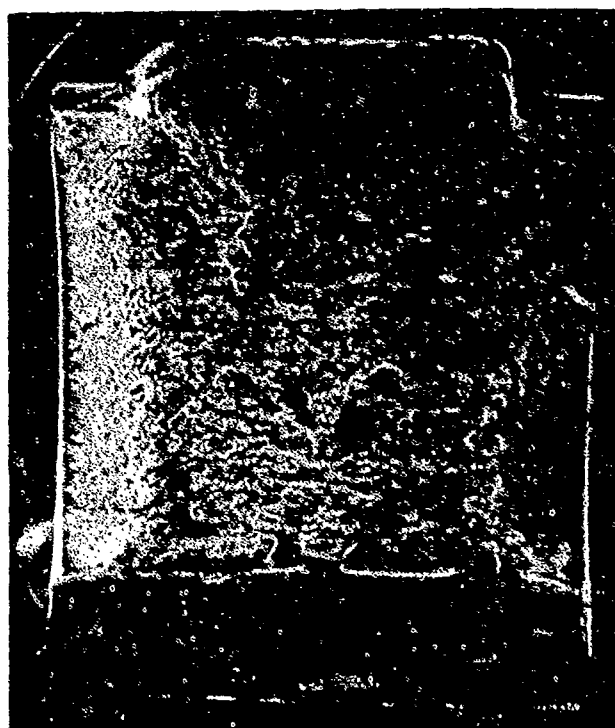
Figure 112. Fracture surface of HY-130 Charpy specimen tested at -18°C , 8x.

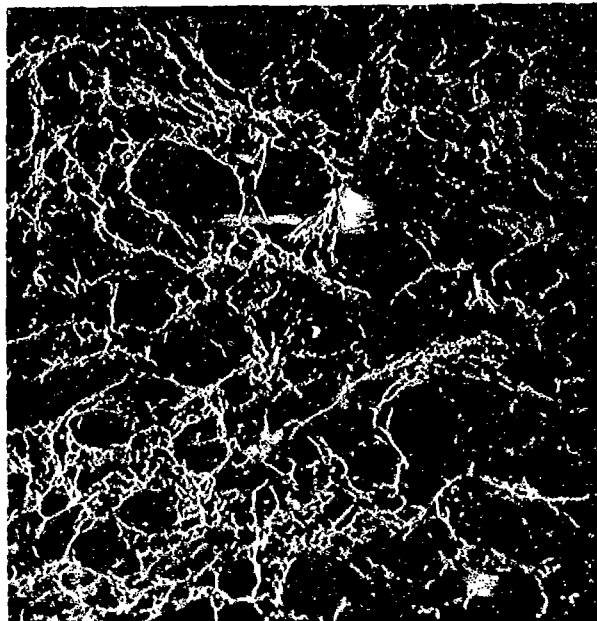
Figure 113. Failure of HY-130 Charpy specimen tested at -18°C , 1600x.

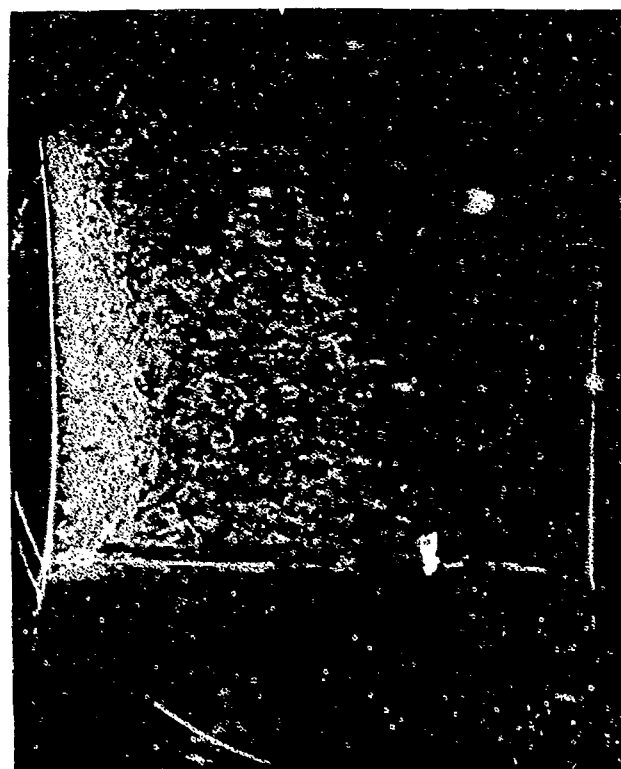
Figure 114. Fracture surface of HY-130 Charpy specimen tested at room temperature, 8x.

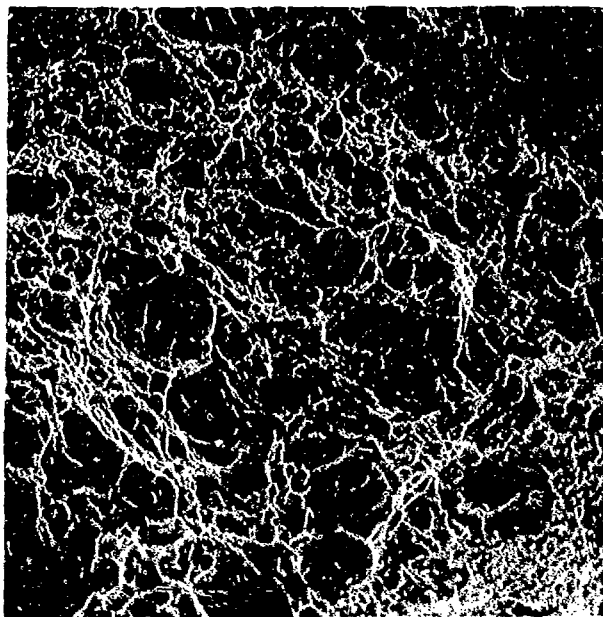
Figure 115. Failure of HY-130 Charpy specimen tested at room temperature by dimple rupture, 1600x.

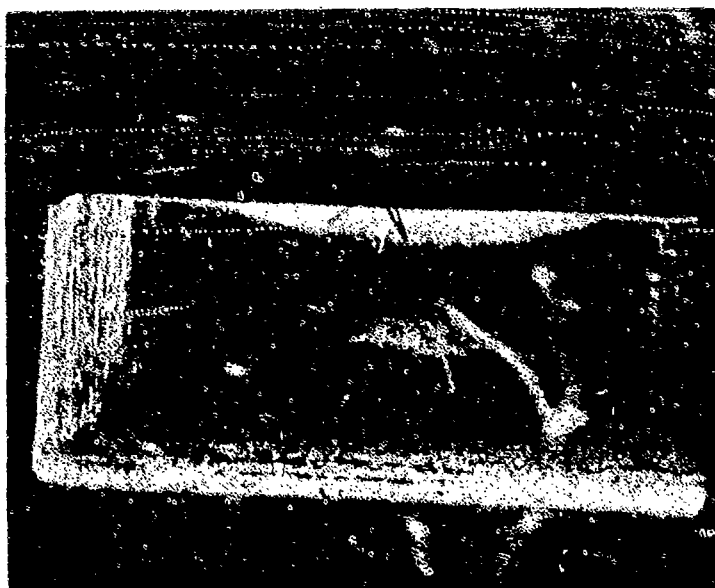
Figure 116. Tensile fracture surface of an AX-110 weld specimen, 25x.

Figure 116 shows the fracture surface of a solid AX-110 weld deposit tested in tension. Failure occurred by microvoid coalescence and dimple rupture (Figure 117). Exposure of an AX-110 weld tensile sample to hydrogen-charging prior to testing produced the fracture surface shown in Figure 118. In one area of the surface small fisheyes were present (Figure 119). The fisheye region (Figure 120) consisted of very small cleavage facets (Figure 121). This failure mode resulted from pockets of entrapped hydrogen gas. The rest of the specimen failed by microvoid coalescence (Figure 122). When the tensile specimens were temper-embrittled prior to testing, the fracture surface (Figure 123) consisted of dimple rupture and microvoid coalescence (Figure 124).
